FIG. 255.—LOWER DAM, OR "PRESA DE LA OLLA," GUANAJUATO, MEXICO. VIEW TAKEN DURING THE FEAST DAY WHEN THE GATES ARE RAISED AND THE RESERVOIR EMPTIED.

The chapter on Masonry Dams has been increased twofold by an attempt to make some mention of all the most notable dams of the world, and many that are very little known. Attention is particularly directed to Plates 1, 2, and 3, in which profiles are shown of all of the leading and better known masonry dams in existence, drawn to uniform scale for easy graphical comparison. No such complete collection of dam profiles has ever before appeared in print, assembled together on a common basis.

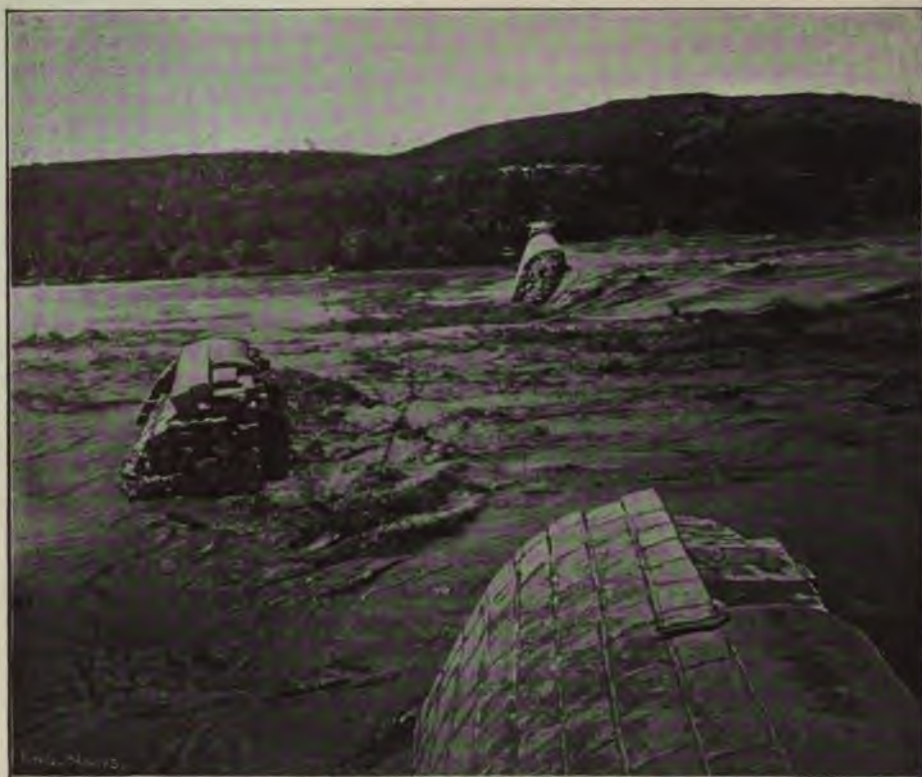
FIG. 230.—AUSTIN DAM, TEXAS. VIEW TAKEN DURING FLOOD, A FEW MINUTES AFTER THE BREAK

Failure of the Austin Dam.—On the 7th of April, 1900, a severe flood in the Colorado River and its tributaries, unprecedented since the erection of the dam, resulted in the failure of this fine structure, with considerable loss of life. About 500 feet of the masonry was first pushed bodily downstream, about 60 feet, apparently sliding on its base, and after a few hours was entirely broken up and washed away, with the exception of a small section, which still stands upright in the position where it was first de-

The appearance of the dam immediately before the break is shown in Fig. 229. Figs. 230 and 231 graphically present the break and the bodily movement of a section of the dam down-stream intact, better than any detailed description. The author is indebted to *Engineering News* for these three cuts.

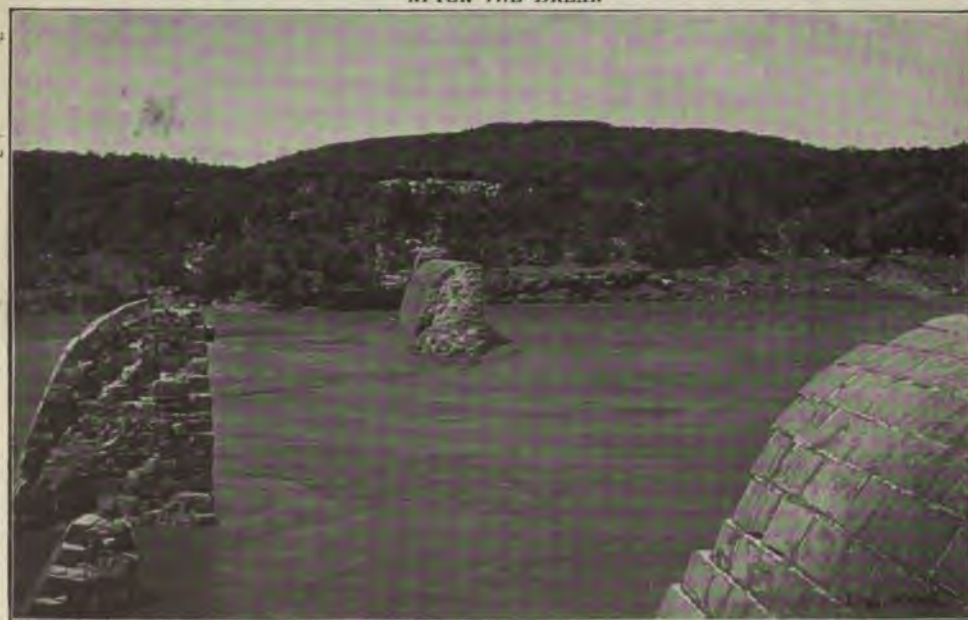
FIG. 231.—AUSTIN DAM, TEXAS, AFTER SUBSIDENCE OF FLOOD OF APRIL 7, 1900. Showing section of masonry moved bodily down-stream.

posited. Measured along the crest, the break left about 500 feet of the dam at the west end and 83 feet at the east end still unaffected. About two-thirds of the wall of the power-house below the dam next the river was also destroyed by the flood. The entire property loss must have exceeded \$500,000. At the time of the break the lake-level had reached a height of 11.07 feet above the crest. The flood was the result of extraordinary rains throughout a very extensive watershed area. In fifteen hours the rainfall at Austin and vicinity was 5 inches, falling on ground already well soaked by previous rains. The maximum flood prior to the catastrophe occurred June 7, 1899, when the water rose to 9.8 feet above the crest of the dam, without injury to the structure. The dam will probably be rebuilt upon safer plans, and precautions taken to anchor it into bed-rock a sufficient depth to prevent it from sliding on its foundations.

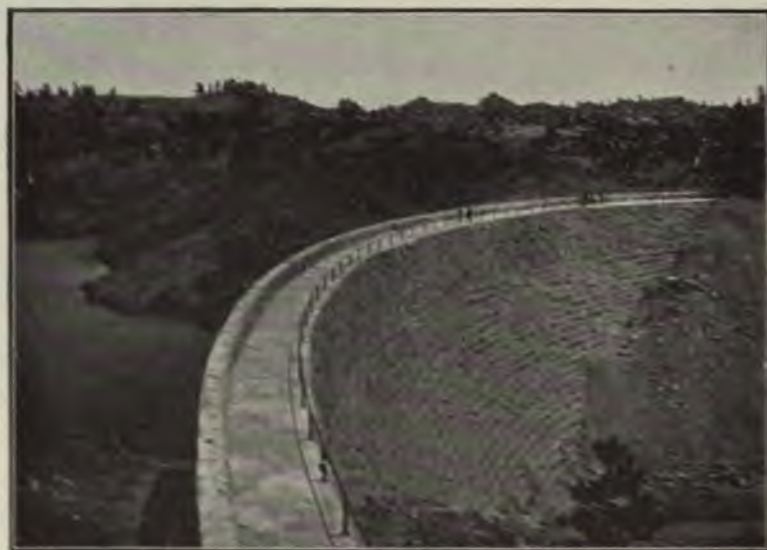
FIG. 232.—GRANITE SPRINGS DAM, CHEYENNE, WYOMING.

Granite Springs Masonry Dam, Wyoming.—There are few dams in Western America more correctly representing the principles of modern science as applied to dam construction, and more generally satisfactory in economy of design and execution than the dam erected in 1903-04 by the City of Cheyenne, Wyoming, for the storage of a domestic water-supply at Granite Springs, on Middle Fork of Crow Creek, 12 miles from the city. The work was designed and built by A. J. Wiley, M. Am. Soc. C. E., to whom the author is indebted for the facts regarding the work, and the accompanying illustrations. (Figs. 232, 233, and 234.)

The dam has an extreme height from foundation to parapet of 96 feet, and is constructed in arch form, with a radius of 300 feet. It is but 10 feet long on the base, and 410 feet in length on top, where its thickness is 10 feet. The base is 56 feet in width, up and down stream. Although curved in plan it is of gravity section and the resultant lines of pressure and weight are within the limits of the middle third, assuming the masonry to have a specific gravity of 2.5, when the reservoir is filled. The dam is built throughout of uncoursed rubble masonry laid in Portland cement mortar, and its cubic contents are 14,422 cubic yards, including a parapet wall 2 feet thick, 3 feet high.

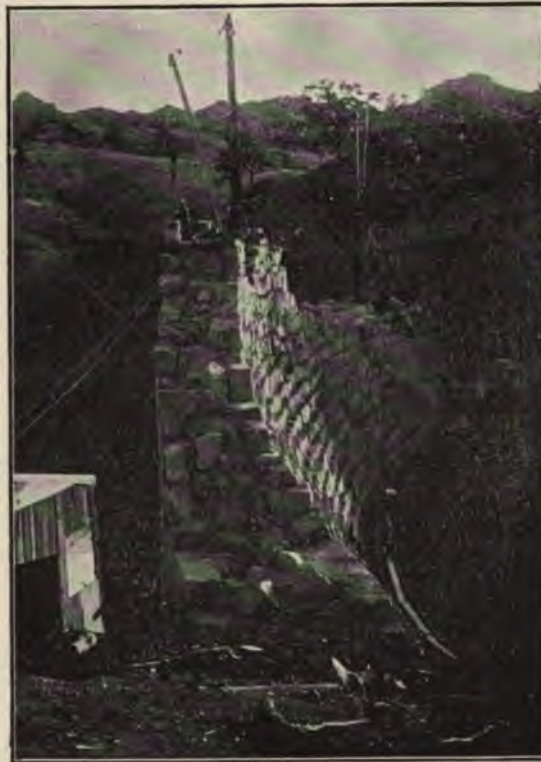
FIG. 233.—GRANITE SPRINGS DAM, WYOMING, SHOWING GENERAL CHARACTER OF RUBBLE MASONRY.

The rock used for the masonry was taken from a granite quarry 100 feet below the dam, and as taken out by blasting ranged in size from spawls to irregular shaped blocks of 4 cubic yards, averaging about 2 cubic yards. The largest rock placed in the wall contained 5 cubic yards and weighed nearly 12 tons, but rock over 3 cubic yards

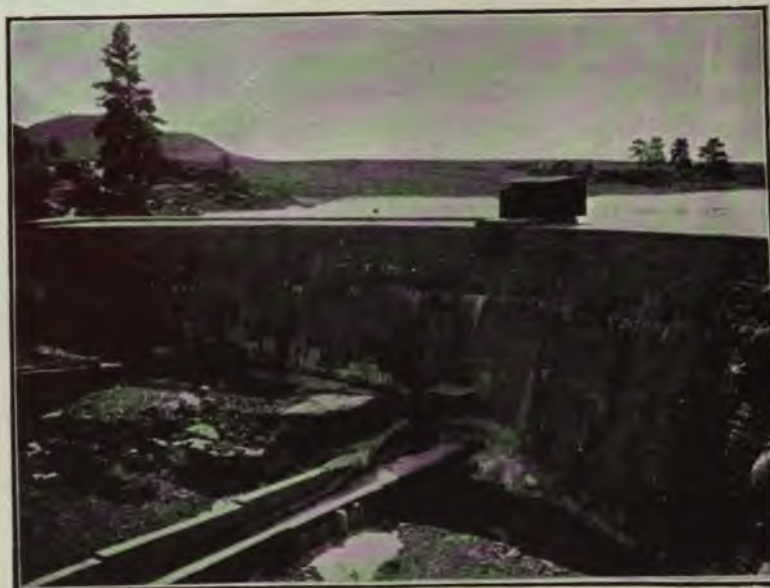
FIG. 235.—DE WEESE DAM, COLORADO

The De Weese Dam, Colorado.—A masonry dam was built in 1905 across Grape Creek, in the Wet Mountain Valley, by Mr. Dal De Weese, for the irrigation of a tract of choice fruit-growing land on the mesa south of the Arkansas river, opposite Canyon City. The dam is curved in plan, and has a maximum height of 44 feet, the crest being at an elevation of 7755 feet above sea level. The dam is arched in plan, of gravity section, and used as an overflow weir for the greater portion of its length. The outlet of the reservoir is 31 feet below the crest. It forms a reservoir of 150 acres area, and has a storage capacity of 1700 acre-feet. Plans have been prepared by the owner for increasing the height 40 feet, and other claimants to the surplus flood waters have proposed making a still higher extension to store water to the level of 80 feet above the present crest, giving a total capacity to the reservoir of about 65,000 acre-feet.

The photographs, Figs. 235 and 236, were taken by the author in January, 1907, and show the general character of the structure.

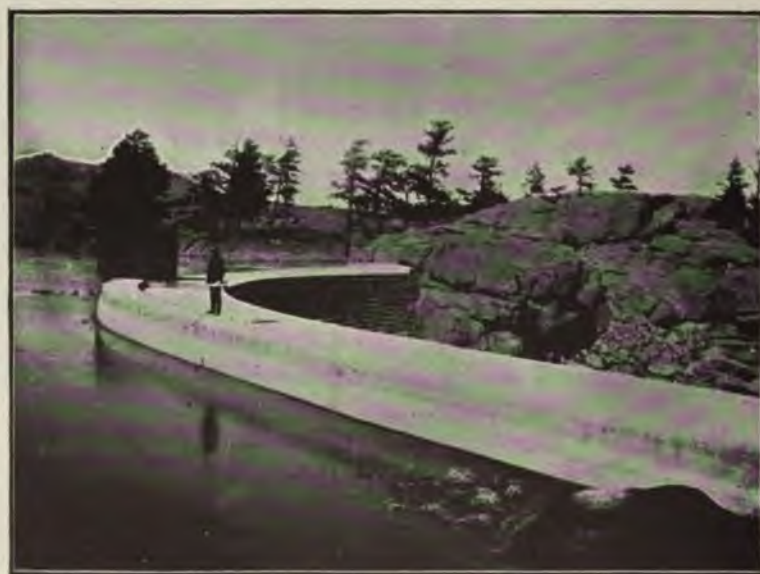
FIG. 236.—DE WEESE DAM, WET MOUNTAIN VALLEY, COLORADO.

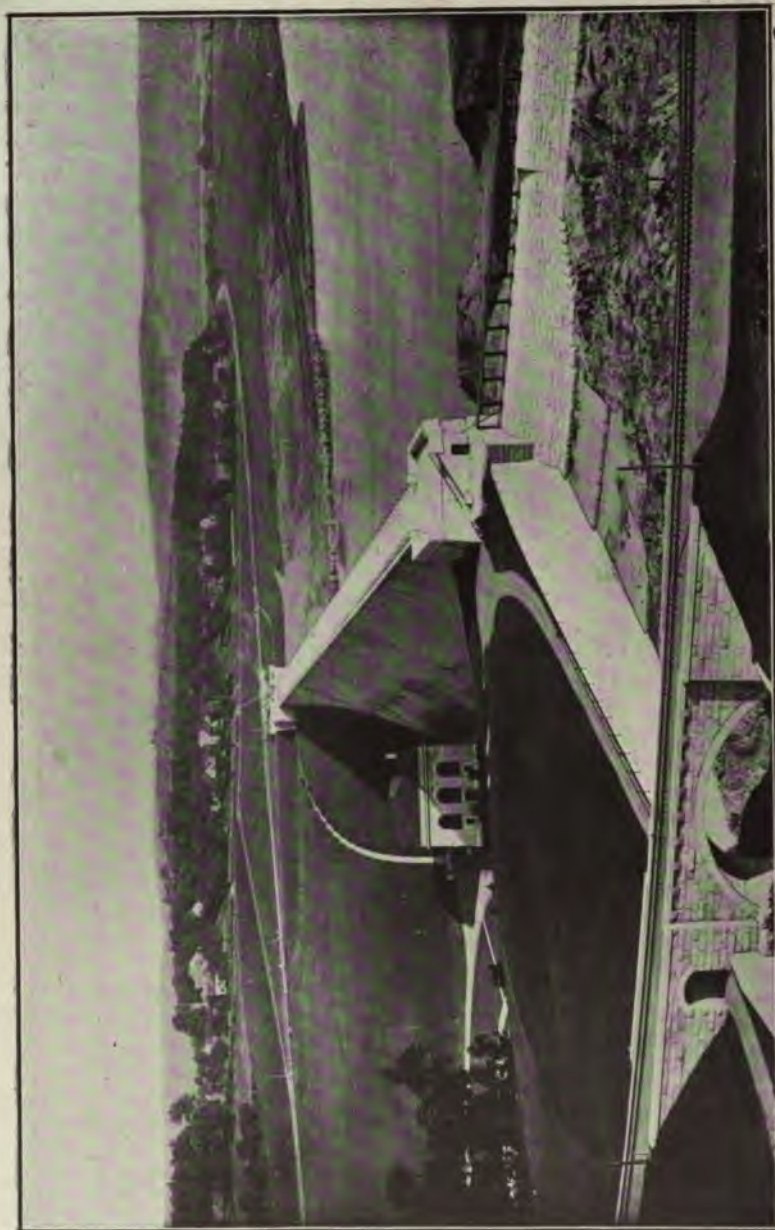
FIG. 239.—WACHUSETT DAM.

The Wachusett Dam, Mass.—To provide for an essential increase in the water supply of the City of Boston and surrounding towns, the Metropolitan Water Board built the Wachusett dam on the south branch of the Nashua

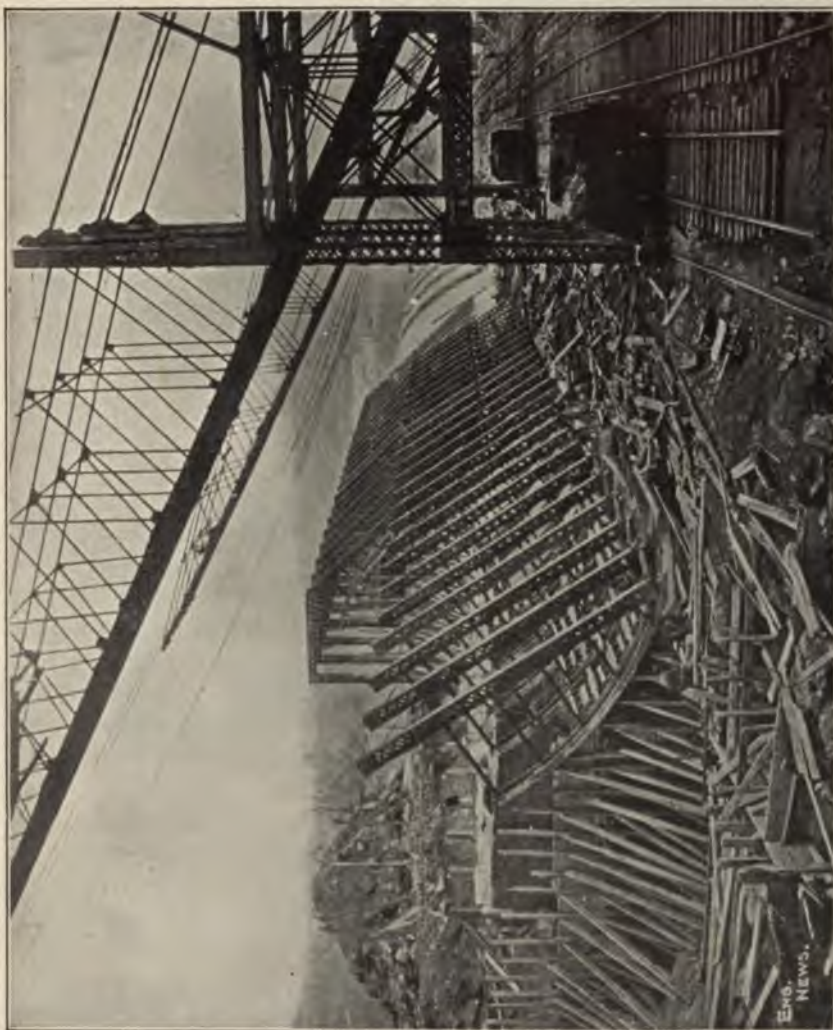
FIG. 243.—McCALLS FERRY DAM, PENNSYLVANIA.

One of the most interesting features of construction was the substantial concrete bridge thrown across the river on a series of arches, to serve as a working platform from which to build the dam. This bridge is 50 feet wide, 2300 feet long, parallel to and 16 feet downstream from the edge of the dam

and power house. Four railway tracts of standard gauge were laid on the bridge, on which three travelling cranes, spanning all four tracks, with a base of 44 feet, are used for handling the steel forms of the dam and the material. They stand so high that cars and engines can pass underneath

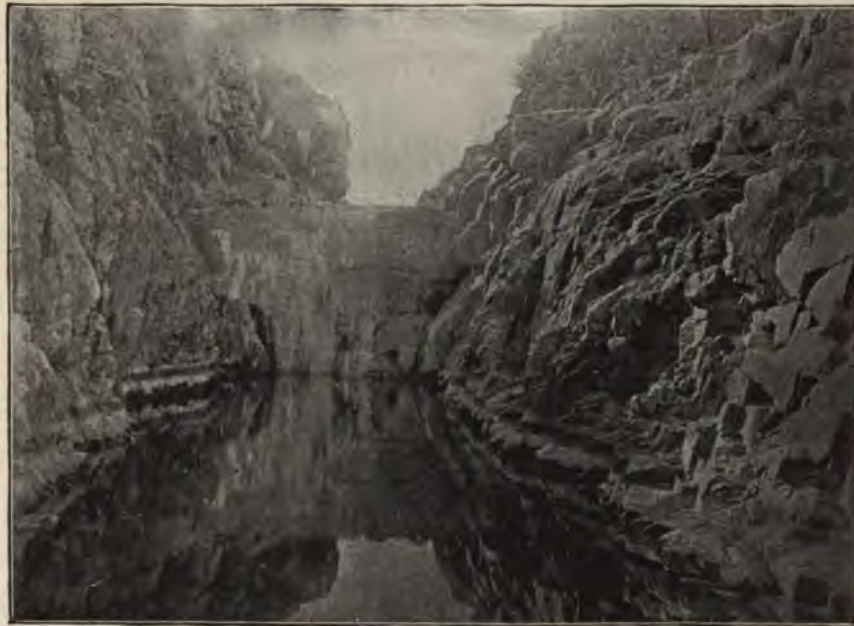
FIG. 250.—UPPER OTAY DAM. FOUNDATION MASONRY.

ervoir will touch the base of the upper dam. The width between solid rock wall at the stream bed is but 20 feet. The dam was started as a masonry structure, and was first built to a height of 34 feet (See Fig. 250).

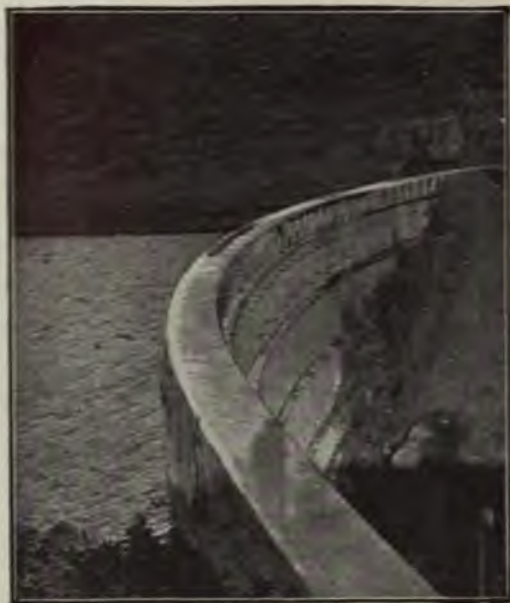
FIG. 251.—UPPER OTAY DAM, IN JANUARY, 1908.

Fig. 251 is a recent photograph of the dam, for which the writer is indebted to Mr. N. L. Hall, one of the engineering staff of the company. Fig. 252 was taken shortly after the completion of the dam.

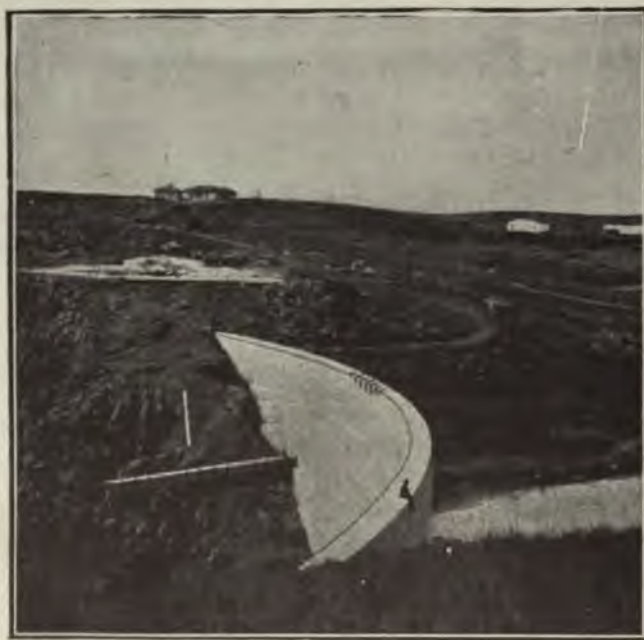
FIG. 252.—UPPER OTAY DAM.

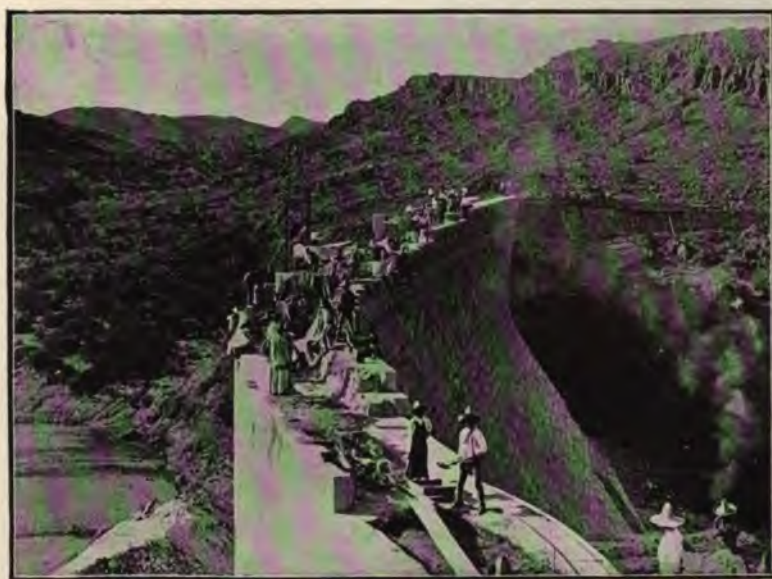
FIG. 257.—MERCEDES DAM, MEXICO, DURING CONSTRUCTION.

Figs. 256, 257, and 258 are excellent photographs, taken during construction and after completion of the dam.

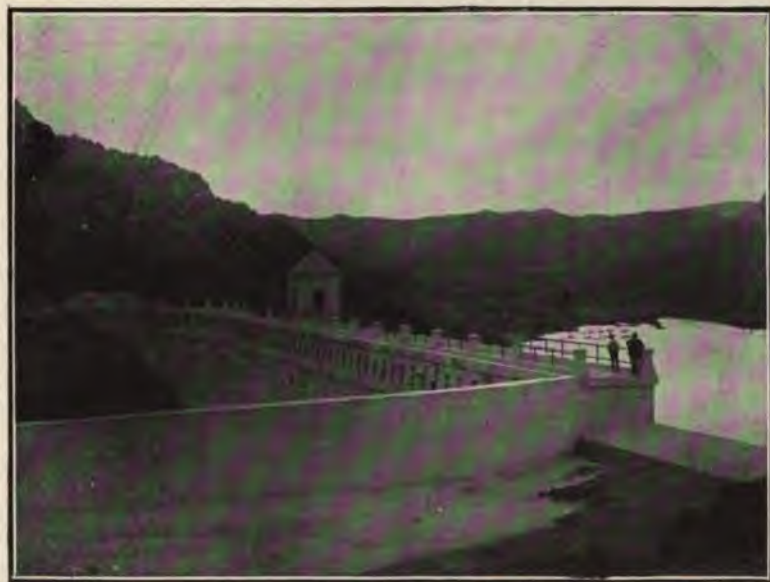
FIG. 258.—MERCEDES DAM, MEXICO, LOOKING ACROSS SPILLWAY CHANNEL, SHOWING CURVED PORTION AT FAR END.

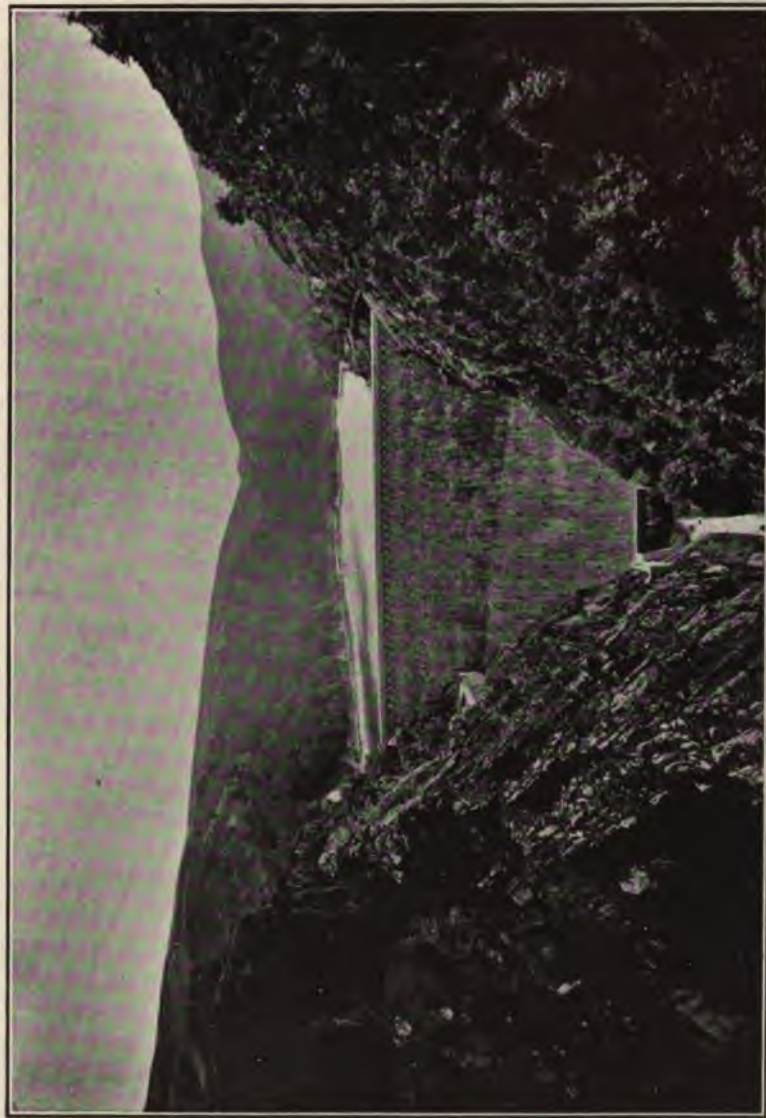
FIG. 260.—GENERAL VIEW OF FURENS DAM, GUOFFRE D'ENFER, ST. ETIENNE, FRANCE, SHOWING RESERVOIR.

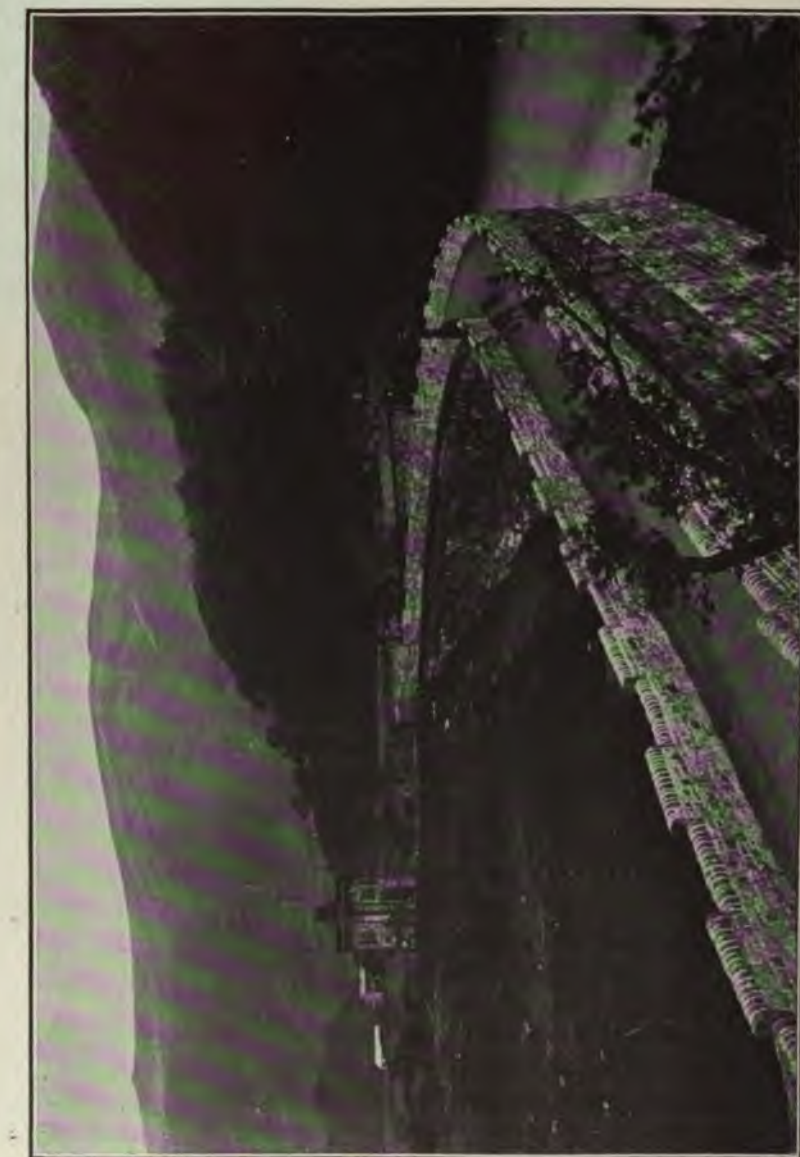
FIG. 274.—THIRLMERE DAM, ENGLAND.

Thirlmere Dam, England (Fig. 272).—A part of the water supply of Manchester is furnished from a reservoir at Thirlmere lake, formed by a masonry dam, built in 1886-1893. The dam has a maximum height of 62 feet, and is 18.5 feet wide on top, forming a roadway with masonry parapets on each side. The width of the dam at the base is 51.8 feet. The up-stream face has a batter of 12.5%, while on the down-stream side is a vertical curve with a radius of 100 feet.

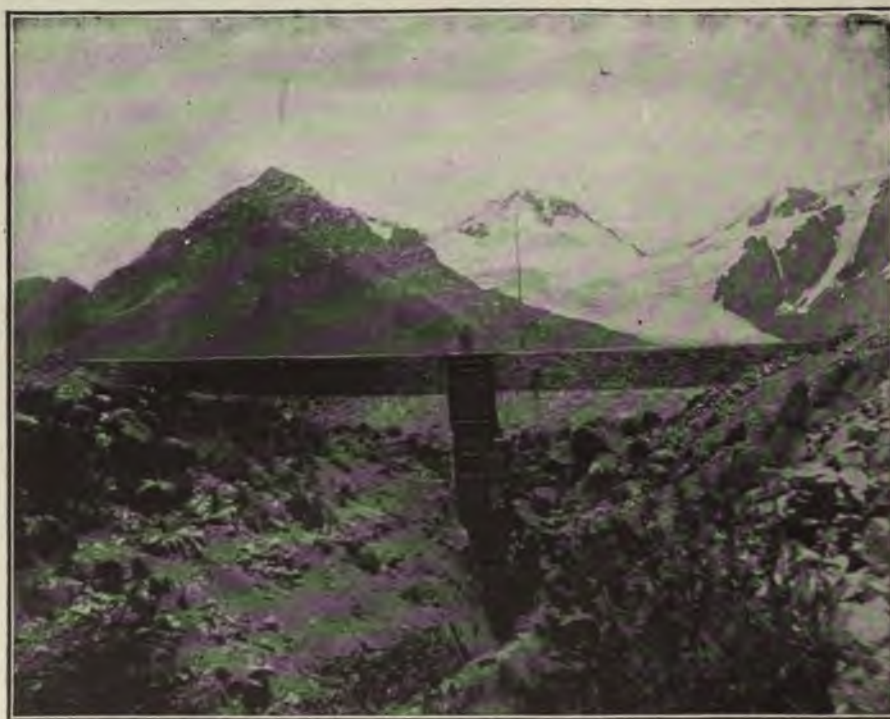
FIG. 277.—CARPA DAM, PERU, SHOWING TYPICAL OUTLET CUT, FILLED WITH STEEL BULKHEAD, GLACIER IN BACKGROUND.

Fig. 277 shows the dam from the down-stream side and the outlet cut from near the bottom to the top of the masonry, which is divided by the cut in two halves, the space being filled with a bulkhead composed of I-beams and steel plates. Water is released at the bottom of the cut through gates in the bulkhead that are raised by screw-stems reaching to the top.

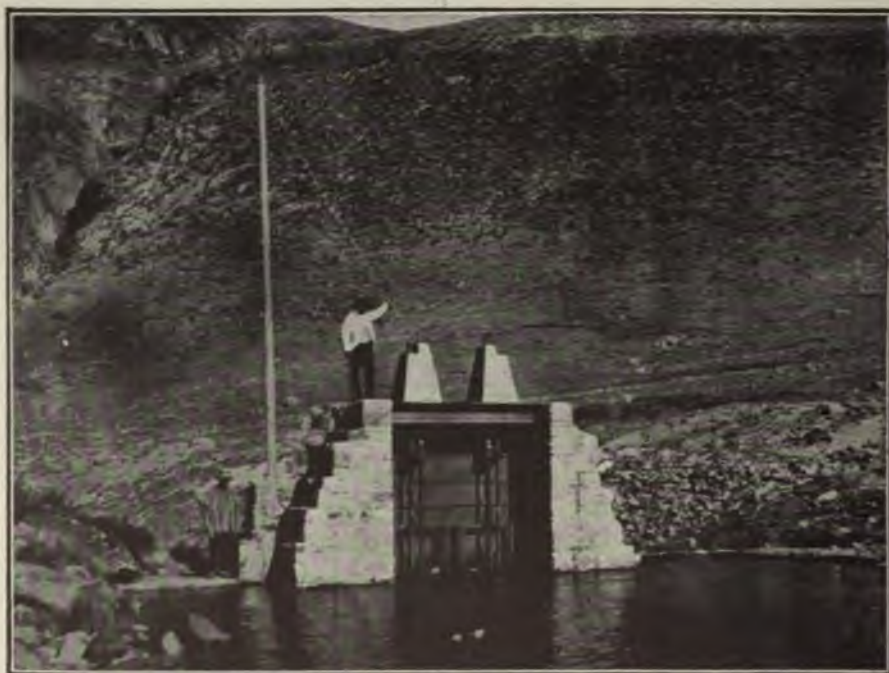
FIG. 279.—SACSA DAM, PERU, DESIGNED TO BE INCREASED IN HEIGHT 8 FEET,
SHOWING GATES. 412

to the storage capacity of the lake. The excavation of the cut required the removal of nearly 18,000 cubic meters of clay, gravel and rock, the cost of which, with the 173 cubic meters of masonry around the gates, and including the latter, was over \$250,000. The photograph (Fig. 279)

clearly shows the typical plan of outlet gates used on all the reservoirs. The other six reservoirs, Huasca, Bucro, Mischa, Huachua, Manca, and Pichua, are natural lakes, converted to use by merely making outlet cuts and erecting controlling gates. Fig. 280 is typical of all of these, and shows the iron work of the bulkhead in the cut, in which the gates are placed at Huasca lake reservoir—the largest of the six, having a capacity of 4228 acre-feet. The total expenditure on these works by the Government was \$983,000. The enormous unit prices paid for the works is suggestive of official graft on an extensive scale.

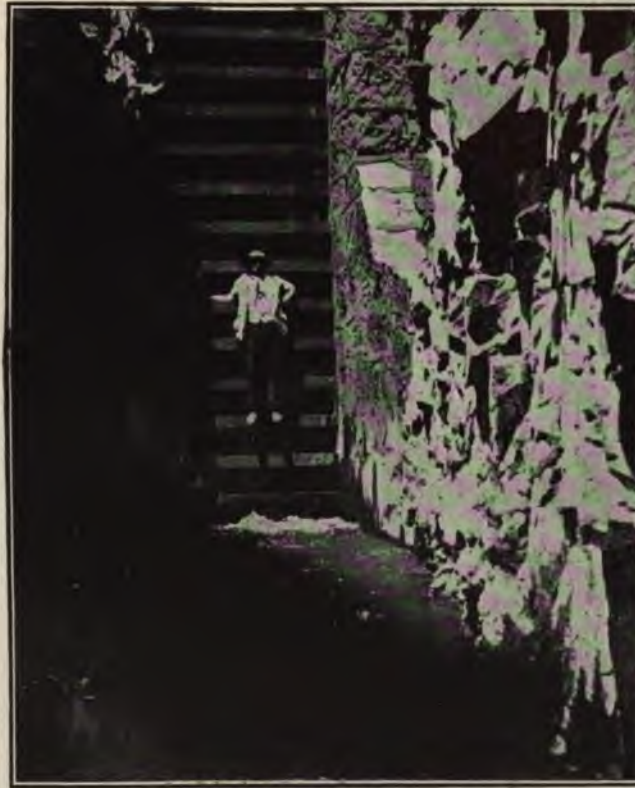
FIG. 280.—HUASCA DAM, PERU, ILLUSTRATING TYPE OF IRON BULKHEADS USED IN OUTLET CUTS OF ALL NINE LAKES USED AS RESERVOIRS.

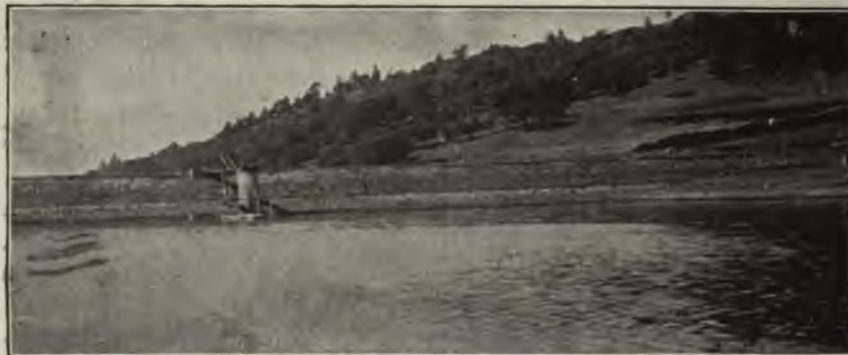
FIG. 285.—VIEW OF CUYAMACA DAM AND OUTLET-TOWER.

Fig. 285 is a view of the dam from the side of the reservoir, showing the tower.

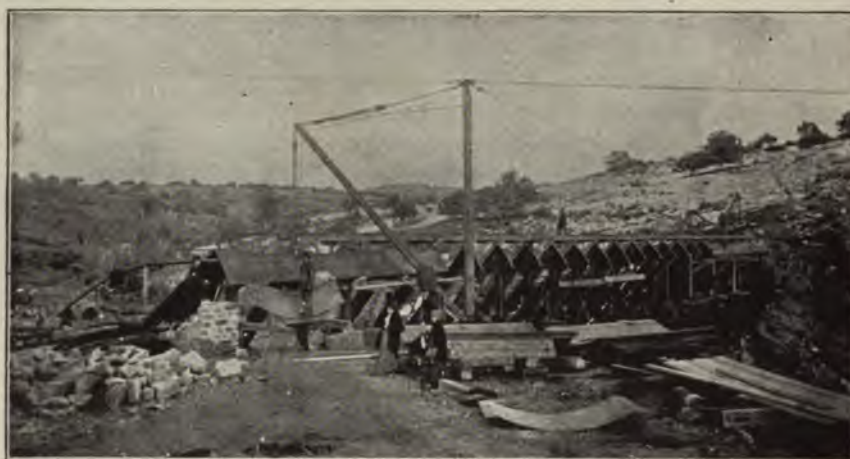
FIG. 294.—ASH FORK, ARIZONA, STEEL DAM, VIEW OF STEEL CONSTRUCTION FROM LOWER SIDE.

Figs. 294 and 295 give an excellent general idea of the construction. Fig. 296 shows a portion of the reservoir, and represents clearly the igneous rock formation of the canyon in which it is located.

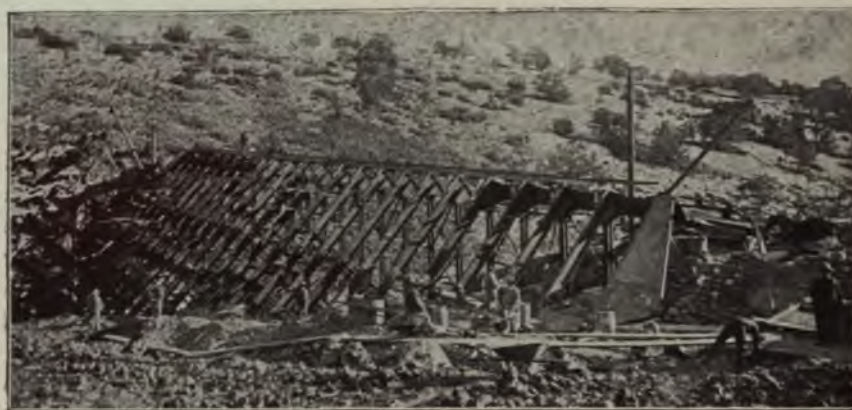
FIG. 295.—ASH FORK, STEEL DAM, SHOWING FRAME READY TO RECEIVE PLATES.

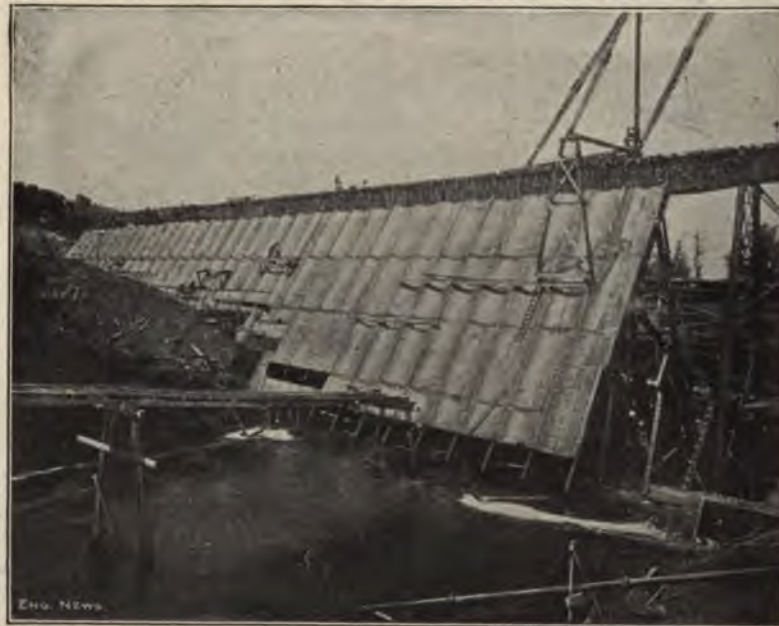
FIG. 297.—REDRIDGE STEEL DAM.

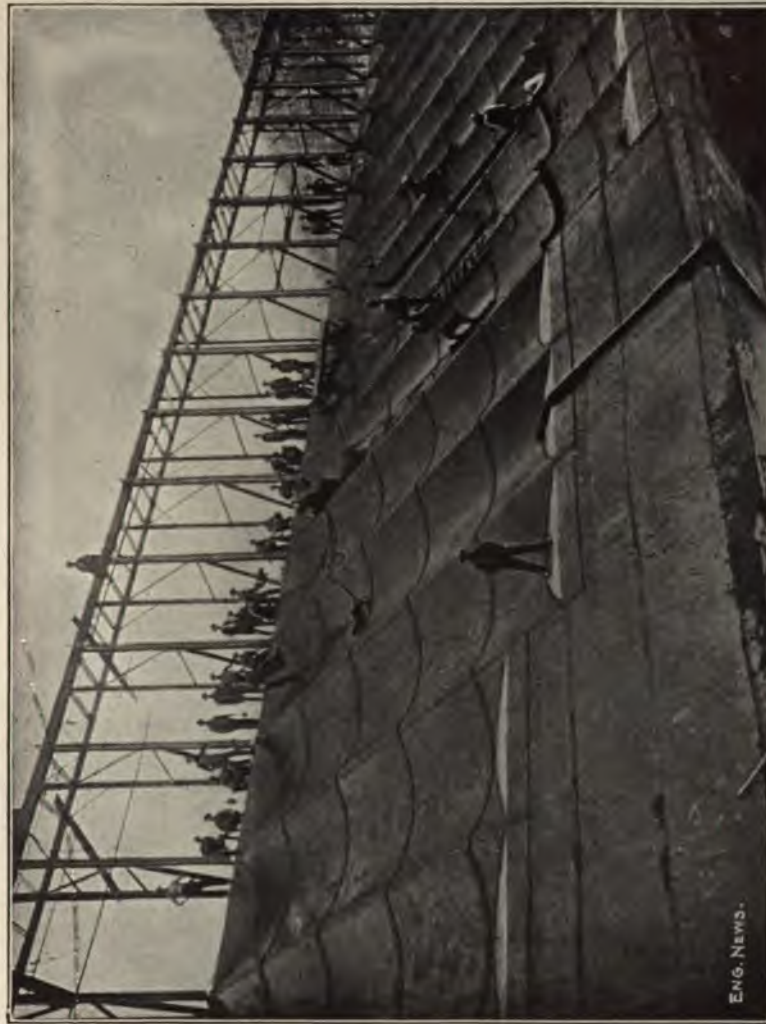
FIG. 300.—HAUSER LAKE DAM, MONTANA.

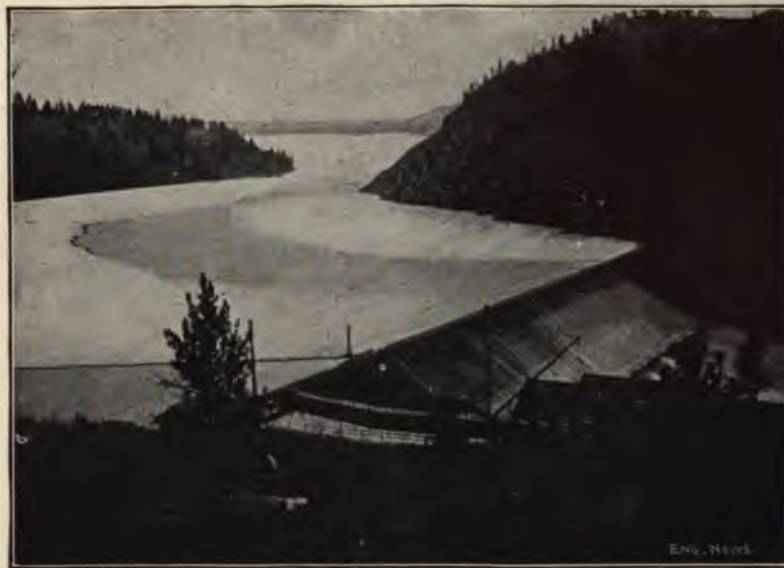
FIG. 302.—COMPLETED HAUSER LAKE DAM NEAR HELENA, MONT.

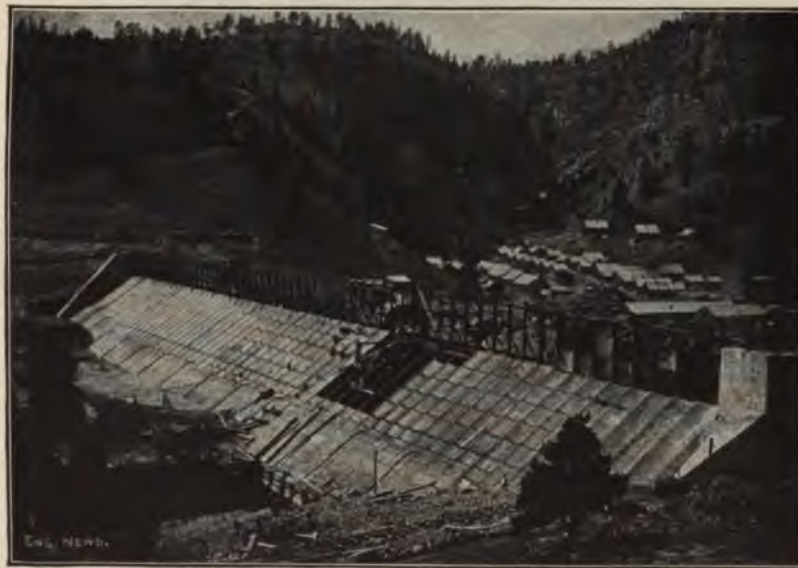
FIG. 303.—HAUSER LAKE DAM, MONTANA, NEARING COMPLETION.

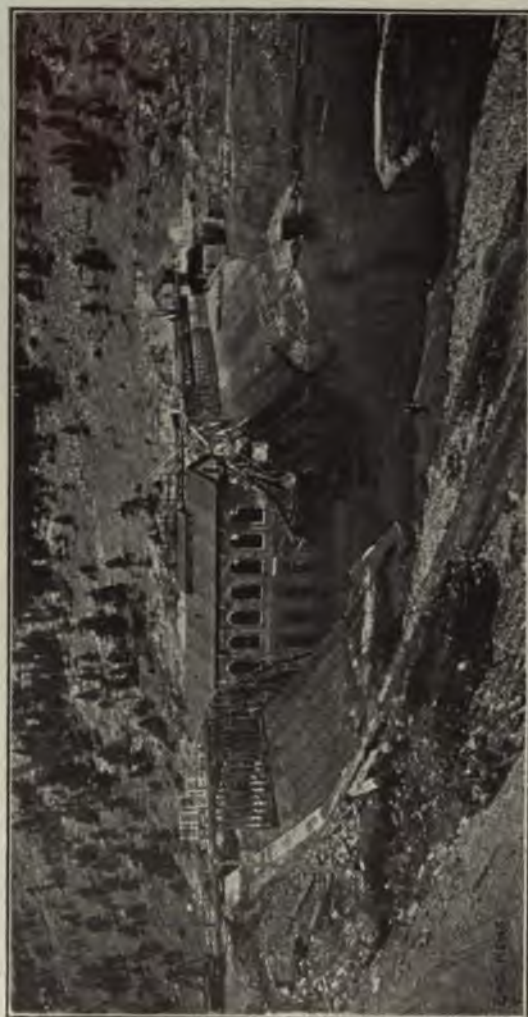
FIG. 304.--VIEW OF THE WRECKED HAUSER LAKE DAM, IN APRIL, 1908.

Failure of the Hauser Lake Dam, Montana.—The new steel dam built on the Missouri river, about 18 miles from Helena, Mont., described on page 499, and but recently completed, was partially destroyed on April 14, 1908, subsequent to the preparation of the description, and a section about 300 feet wide in the center of the dam was washed out. The failure, as described in *Engineering News*, April 30, 1908, with photographs of the ruined structure, was caused by water undermining the rubble masonry fill and the steel sheet-piling at the up-stream toe of the dam. This piling had been used over a portion of the channel where bed-rock could not be reached and where the gravel of the river-bed is of great depth. The maximum depth reached by the piling driven in this gravel was 35 feet. The concrete placed over the top of the piling, which formed the junction between the expansion joint of the steel work and the sheet piling, is said to have been placed in a depth of 10 feet or more of water, so that its quality may have been very poor. The total damage caused by the break is estimated at \$250,000 to \$300,000, requiring six months time to make the necessary repairs. Figs. 302 and 303 illustrate the dam as completed, and just prior to completion. The wreck of the dam is clearly shown by Figs. 304 and 305. These interesting cuts have been kindly loaned by *Engineering News*.

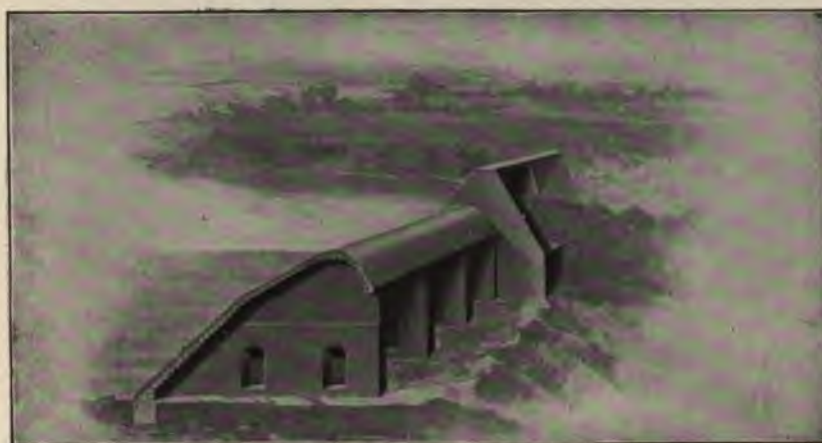
FIG. 307.

Fig. 307 shows in perspective and section the form adapted to low heads and hard foundations. It consists of a series of piers or buttresses, spaced 12 to 18 feet apart on centers, and covered with a deck of concrete, reinforced between the different bays as a beam, in which the tension members of steel are placed near to the under side, leaving from ten inches to several feet of concrete between the steel bars and the water. The thickness of the concrete sheet necessarily increased from top to bottom with the increase of head. But little reinforcement is used in the piers, except at

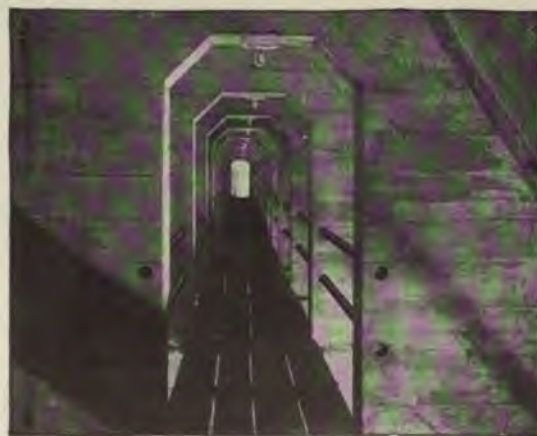
FIG. 309.

river to the other, as a substitute for a foot-bridge over the stream. Such a passage is illustrated in Fig. 309.

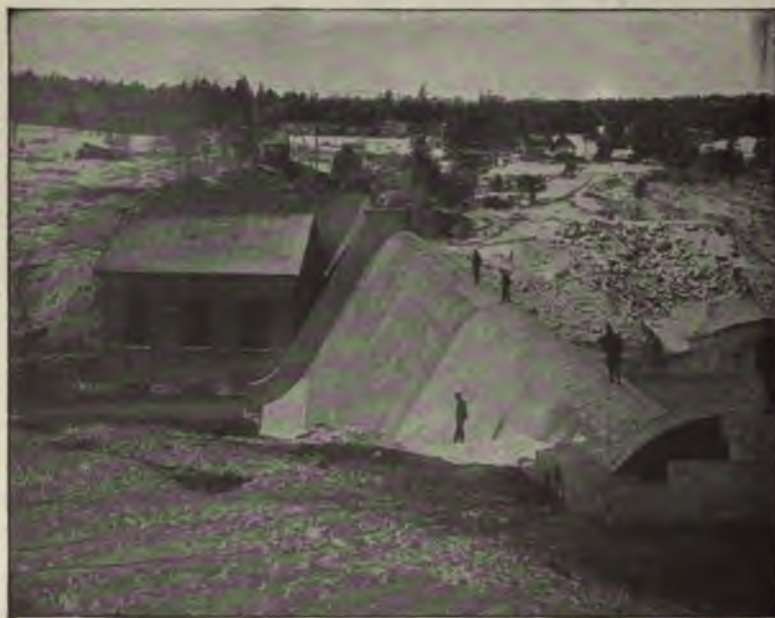
FIG. 316.—ELLSWORTH DAM, MAINE.

It is founded on granite, and the transverse profiles are very irregular, as shown in Fig. 305, which is a section through the rollway. The maximum height of the dam is 71.5 feet, in the bulkhead portion, back of the power-house. The rollway is 65 feet high. The total length of the dam is about 500 feet. The general plan, elevation and section of the structure are shown in Fig. 306. The space underneath the bulkhead and immediately in the rear of the power-house is utilized as a transformer-house, store-house, machine-shop, etc., while the power-house is approached from the town on the opposite side of the river by a tunnel beneath the low part of the crest and a passage at different levels entirely through the body of the dam. The structure is shown in Figs. 312 and 316.

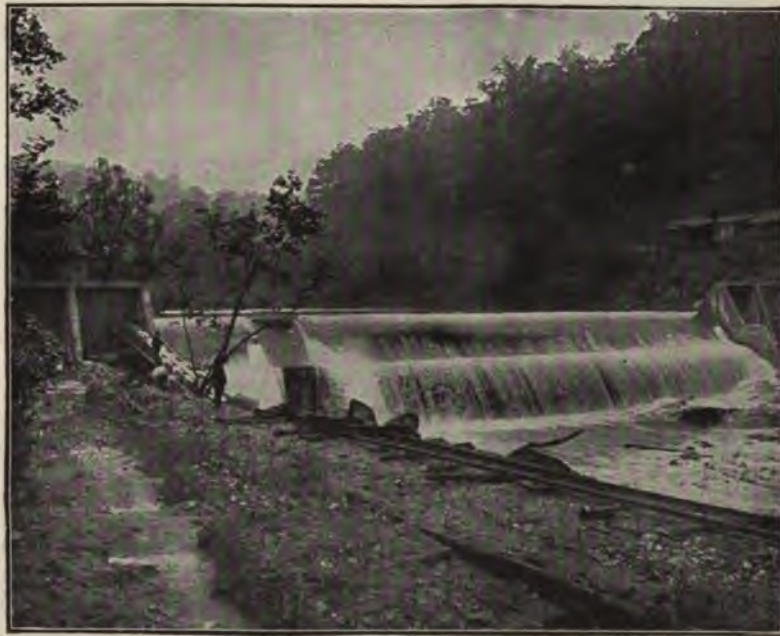
FIG. 317.—PATAPSCO DAM, ILCHESTER, MARYLAND.

became necessary to utilize the room in the hollow interior for the power-house, in which three units of 500 H. P. were snugly installed. The dam is of the half-apron type, affording ample daylight on the downstream side. The cubic contents of this dam are but 2200 cubic yards. A general view is shown on Fig. 317.

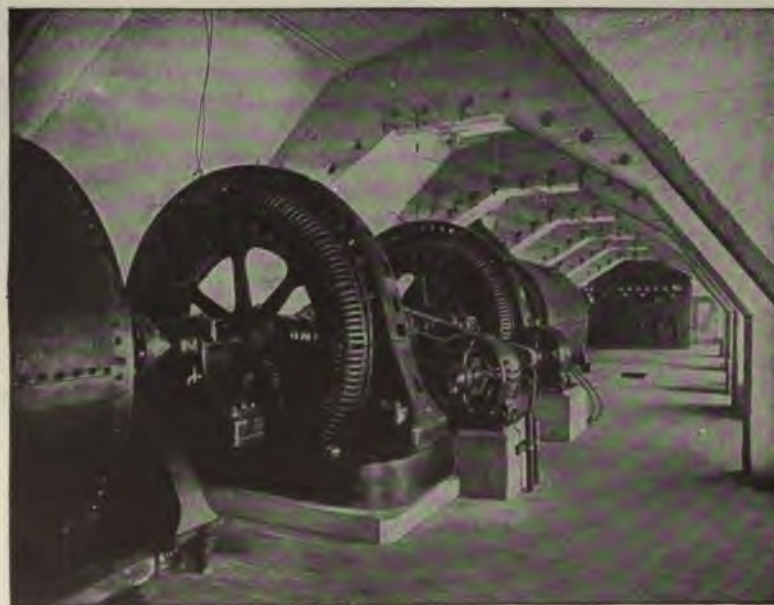
FIG. 319.—INTERIOR OF PATAPSCO SUBMERGED POWER-HOUSE.

Fig. 318 is a cross-section of the dam with its enclosed power-house, and Fig. 319 shows an interior view of the power house after completion.

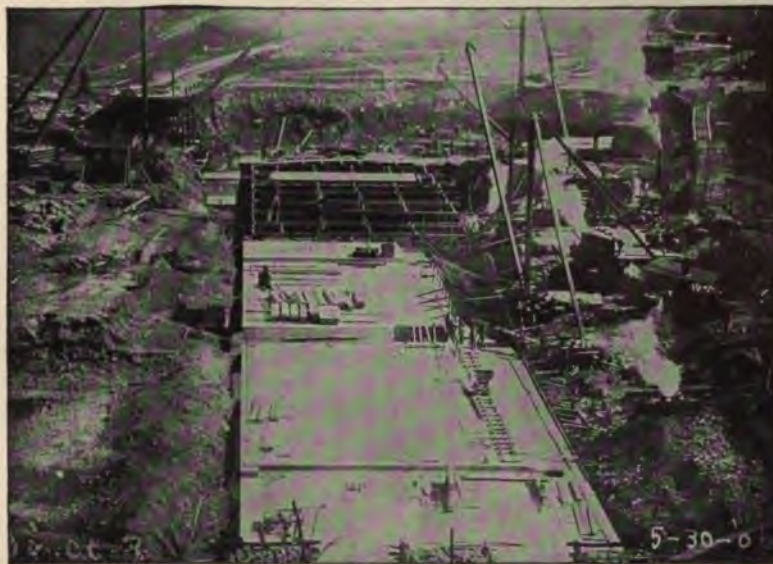
FIG. 320.—FLOOR CONSTRUCTION, JUNIATA DAM.

The completed floor forming the base for the superstructure of the rollway is illustrated by the photograph, Fig. 320, on page 480.

The reinforcement of this floor is proportioned to distribute the pressure to an average of 1.3 tons per square foot.

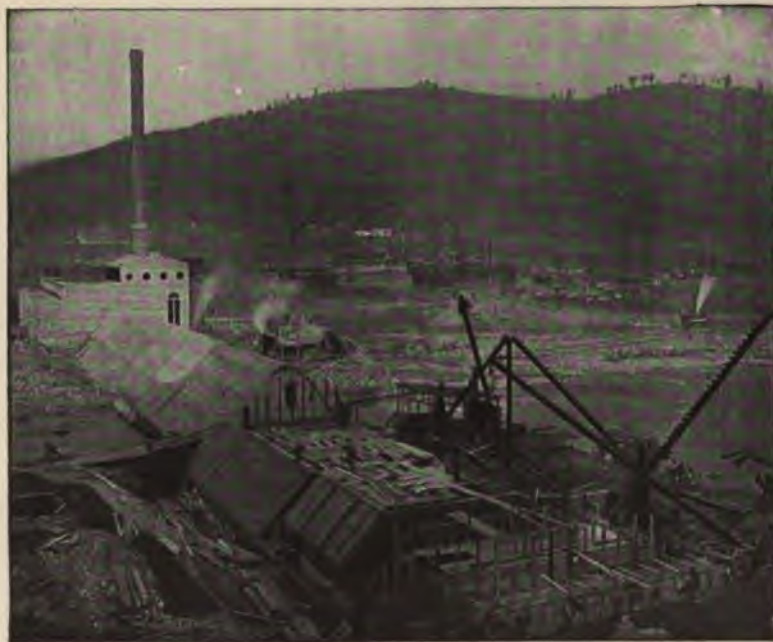
FIG. 321.—JUNIATA DAM, AND POWER-HOUSE PARTIALLY COMPLETED.

Fig. 321 gives a clear view of the work at an advanced stage, with the river flowing through openings beyond the cofferdam, and Fig. 323 shows the completed dam and power-house. The dam in the rollway section is 28 feet high and 460 feet long. It contains 6400 cubic yards of concrete, including abutments and bulkheads.

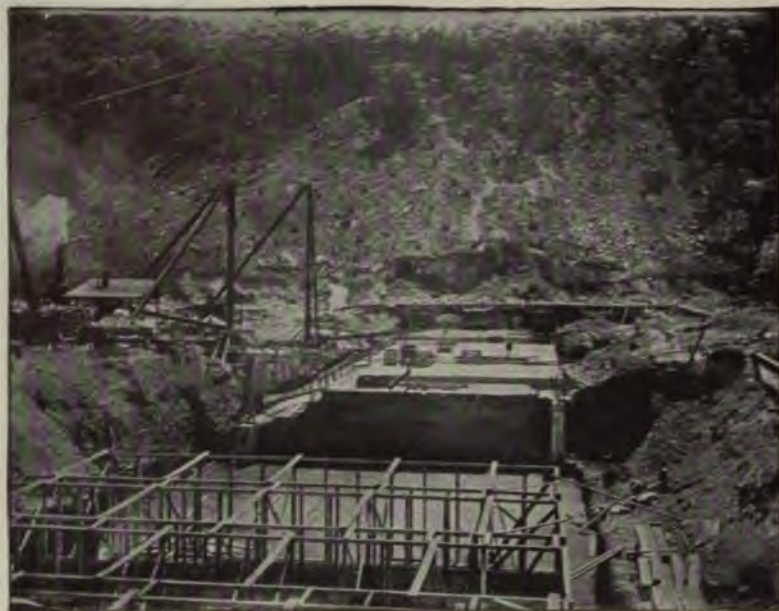
FIG. 322. —WHEEL PIT AND CUT-OFF WALLS, JUNIATA DAM.

The Juniata Dam, Huntingdon, Pa.—This interesting dam is built on a foundation of porous gravel, underlaid by hardpan at a depth of about 18 feet. A trench was first sunk to the hardpan at each edge of the dam, and a reinforced concrete cut-off wall molded therein, intercepting the underflow. (See Fig. 322.)

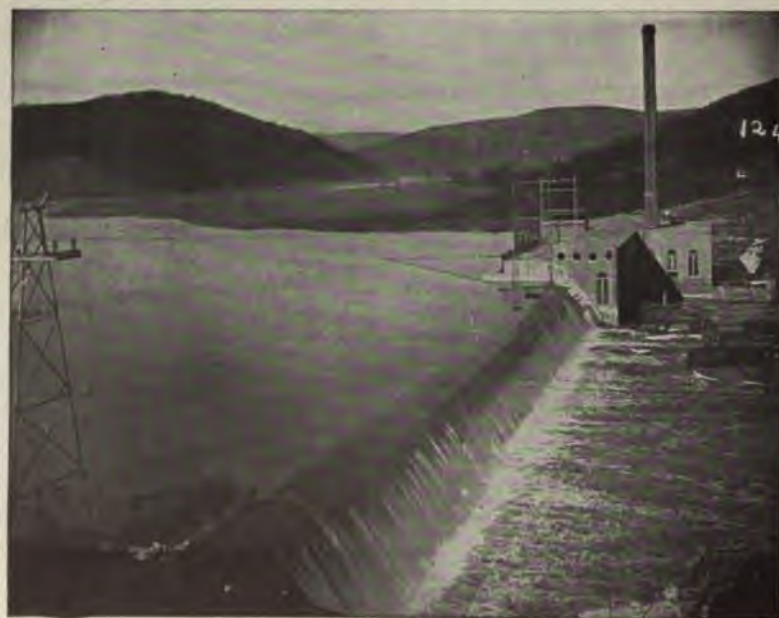
FIG. 323.—VIEW OF COMPLETED JUNIATA DAM.

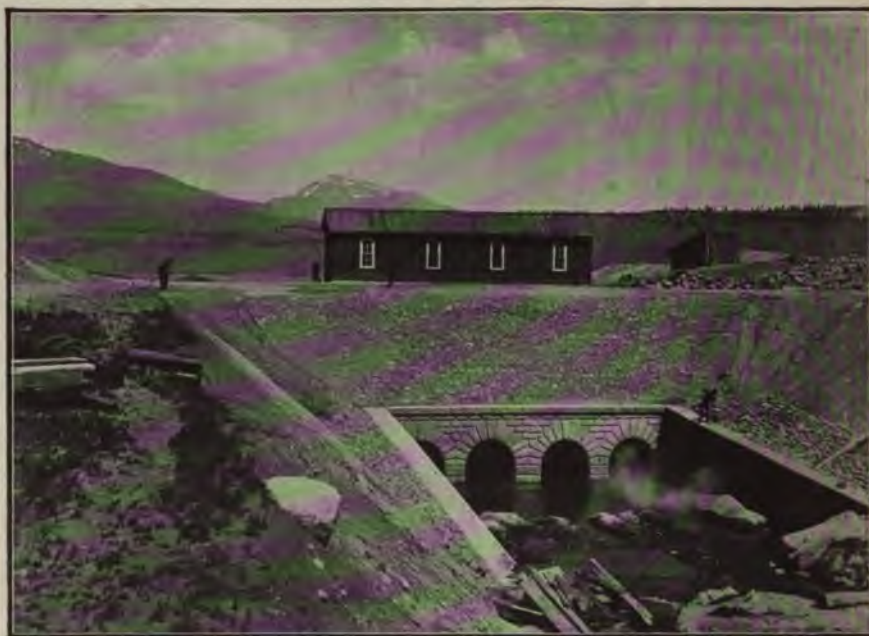
FIG. 331.—TWIN LAKES, COLORADO, MASONRY DAM OVER OUTLET, WITH EARTH BACKING, GATE-HOUSE, AND OUTLET CULVERTS.
